Manhole Inspection Summary

Manhole # S11EE1002MH

Insp Date: **1/23/09 1:24 PM**

Location Address: **WABASH AVE**

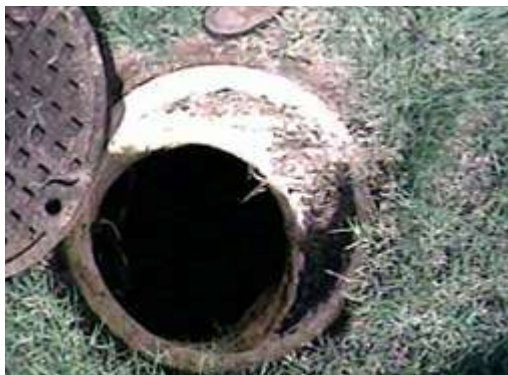
Top View

FRAME OFFSET

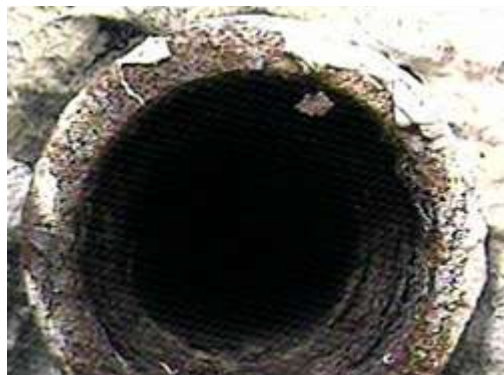
OVERFLOW invert 3.92 ft

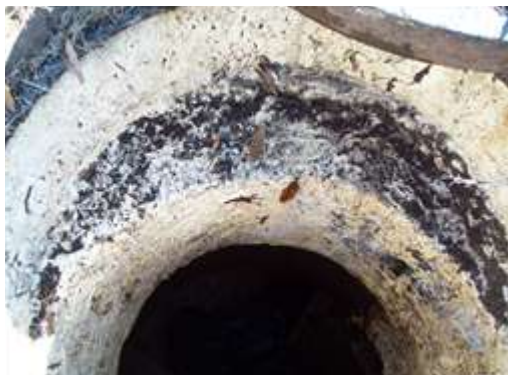
THATS HOW THE MH WAS MADE NOT
A OFFSET

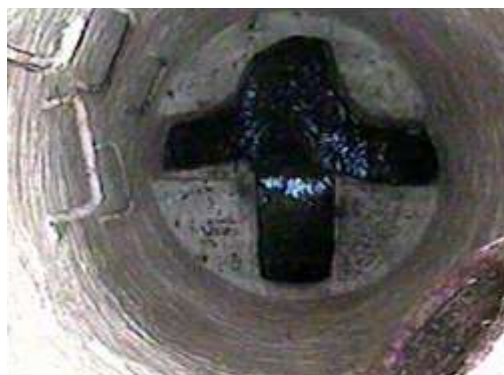
Defect 1

Count: **6** Missing: **0** ☒ **Corroded**

CORRODED STEPS

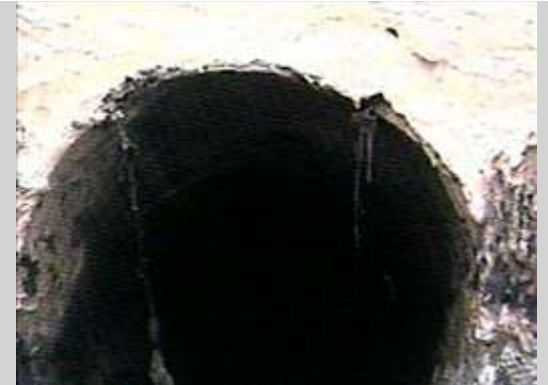
12 O'Clock Outflow

12 in. Circular Gravity Sewer
Pipe Out @ 12 O'Clock

Pipe Height: (in.) Direct
Pipe Material: **PVC** ☐ Pipe Lined
Invert Depth: **10.65** (ft.) Flow Characteristics: **Fast**
Deposits: ☒ None ☐ Mud ☐ Sludge ☐ Debris ☐ Grease
Silt Depth: (in.) Deposits Extent:
Infiltration: **None** Pipe Seal Cond: **Sound**

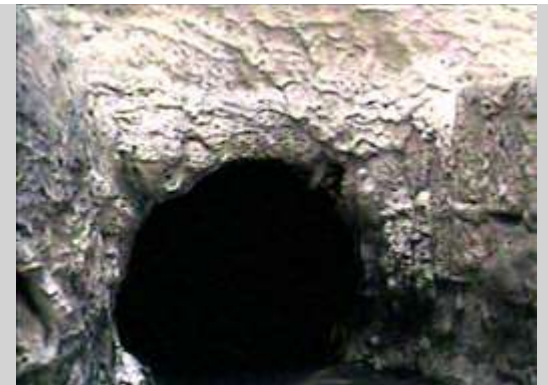
3 O'Clock Inflow

10 in. Circular Gravity Sewer
Pipe In @ 3 O'Clock

Pipe Height: (in.) Direct
Pipe Material: **Clay** ☐ Pipe Lined
Invert Depth: **10.60** (ft.) Flow Characteristics: **Slow**
Deposits: ☒ None ☐ Mud ☐ Sludge ☐ Debris ☐ Grease
Silt Depth: (in.) Deposits Extent:
Infiltration: **None** Pipe Seal Cond: **Sound**

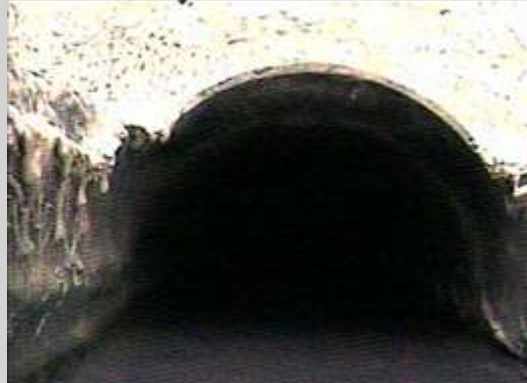
6 O'Clock Inflow

12 in. Circular Gravity Sewer

Pipe In @ 6 O'Clock

Pipe Material: **PVC** ☐ Pipe Lined

Invert Depth: **10.58** (ft.) Flow Characteristics: **Fast**

Infiltration: **None** Pipe Seal Cond: **Sound**

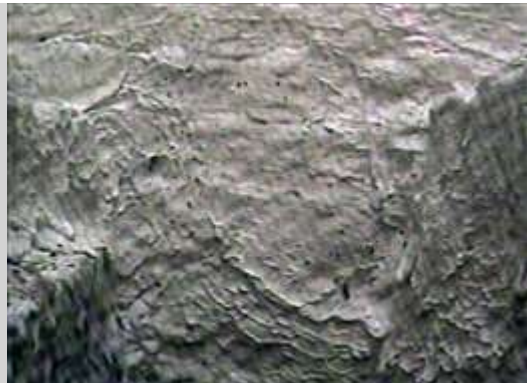
9 O'Clock Inflow

10 in. Circular Gravity Sewer

Pipe In @ 9 O'Clock

ABANDONED

Pipe Material: **Unknown** ☐ Pipe Lined

Invert Depth: **10.50** (ft.) Flow Characteristics: **None**

Connects To: **Stub connection / abandoned**
